NASA TN D-3677

EVALUATION OF CROSS-POINTER-TYPE INSTRUMENT DISPLAY IN LANDING APPROACHES WITH A HELICOPTER

by William Gracey, Robert W. Sommer, and Don F. Tibbs

Langley Research Center

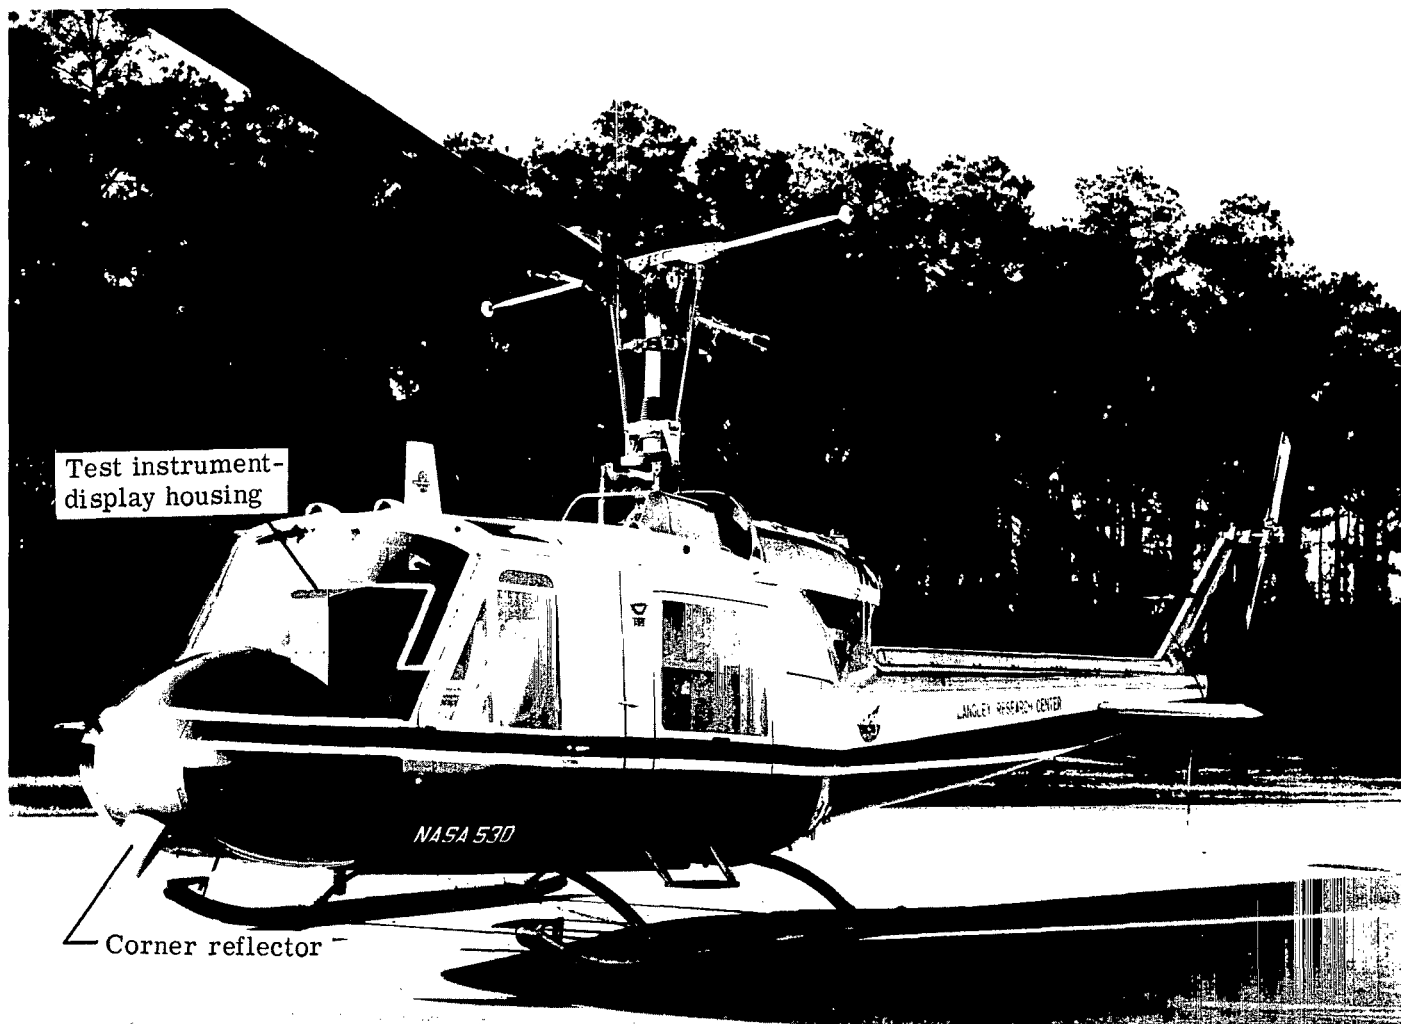
L-65-8688.1

Figure 5.- Test helicopter.

The test aircraft used for the evaluation of the instrument display was a 10-place, turbine-powered, single-rotor helicopter (fig. 5) having dual (side by side) controls. This helicopter was not equipped with artificial stabilization equipment.

The test instrument display was installed on a special panel on the left side of the cockpit. The display was located directly in front of the pilot at a height more nearly at eye level than the aircraft instrument panel. Because of the depth of the instruments, it was necessary to enclose them in a housing that protruded through the windshield.

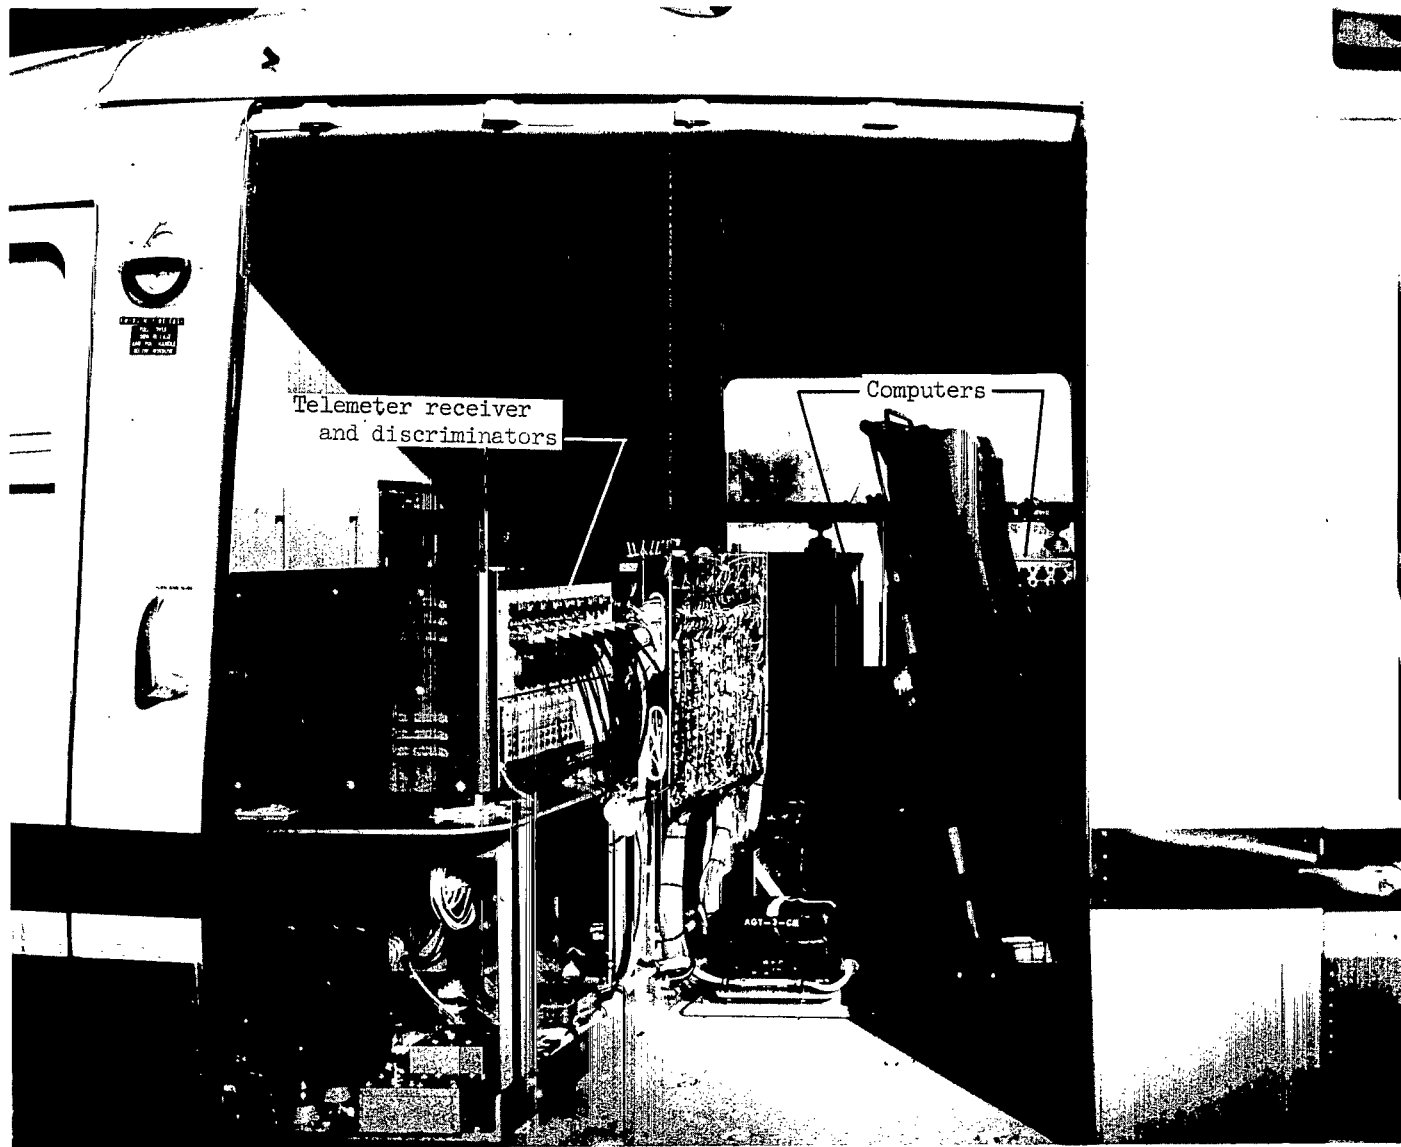
L-65-8687.1

Figure 20.- Airborne guidance equipment.
